SMOKY LAKE COUNTY

AGENDA: County Council Budget Meeting to be held on
Thursday, September 10th, 2020, at 9:00 A.M.,
in the County Council Chambers, Smoky Lake.

4.1 Smoky Lake County Administration Building Assessment ©

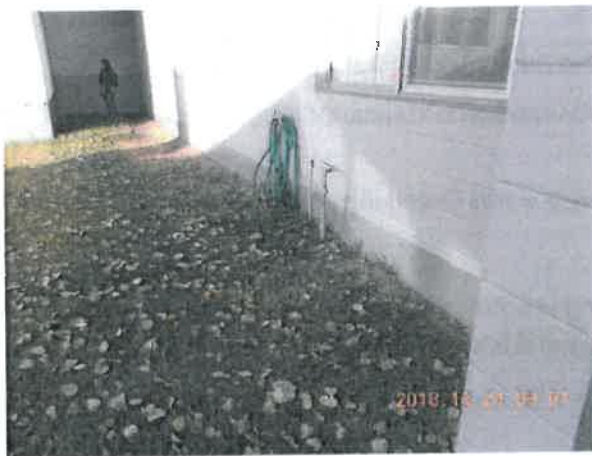
As site grading was not included in this scope of work, it is recommended that a grading professional perform a review of the grading around the structure.

Figure 2-1
Viewing Depression at South Wall
of Chambers

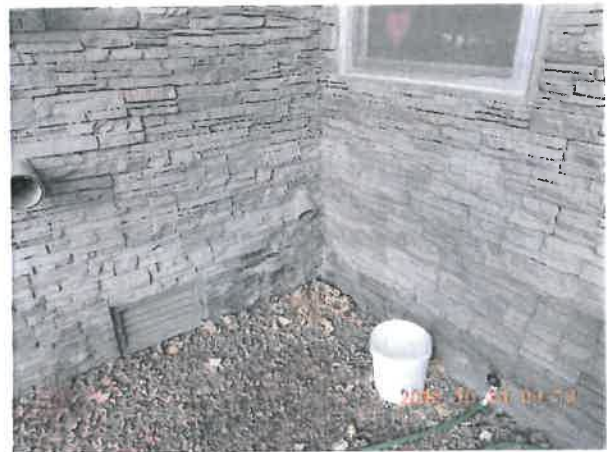
Figure 2-2
Missing Splash Pad Under Roof Drain
Near Main Entrance

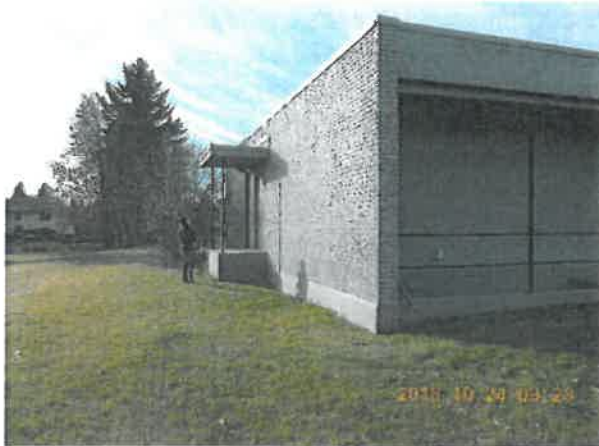
Figure 2-3
Viewing Negative Grading at East Wall

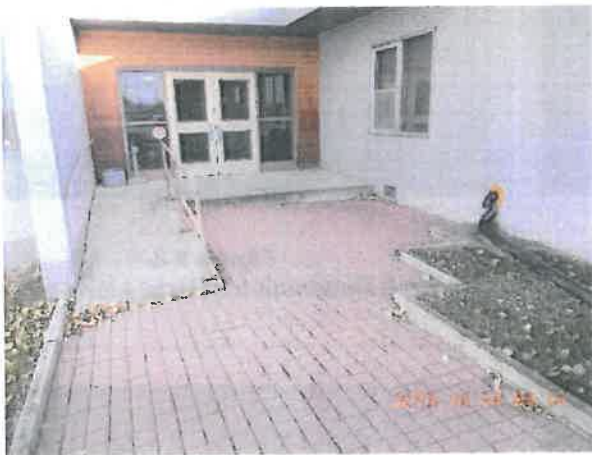
Figure 2-7
Viewing Brick Walkway and Access Ramp to Council Chambers

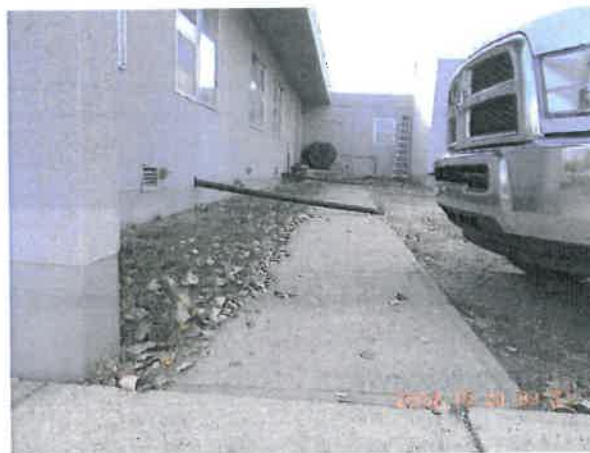
Concrete sidewalks are located along the south and northwest sides of the building. The concrete sidewalks are in generally good condition for their age, although wide transverse cracks have developed at numerous locations – with some having differential settlement at their locations. Cracking is typical in concrete sidewalks and is not seen as a high priority concern. The cracks should be sealed to reduce water infiltration to mitigate freeze thaw action and subgrade saturation. Lips should also be ground down to eliminate tripping hazard.

Figure 2-9
Viewing West Sidewalk

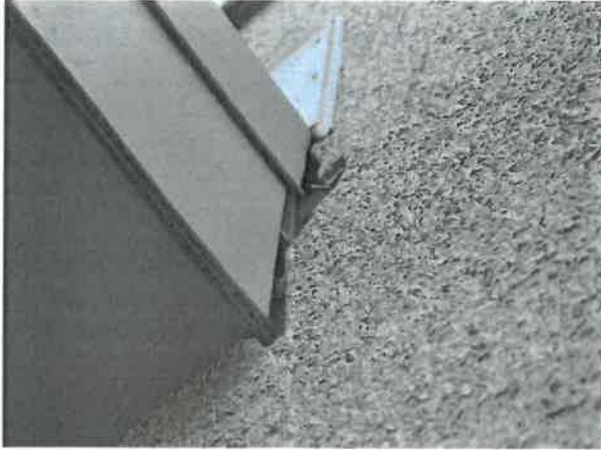
Figure 3-1
Missing Stucco at Canopy to Wall Location

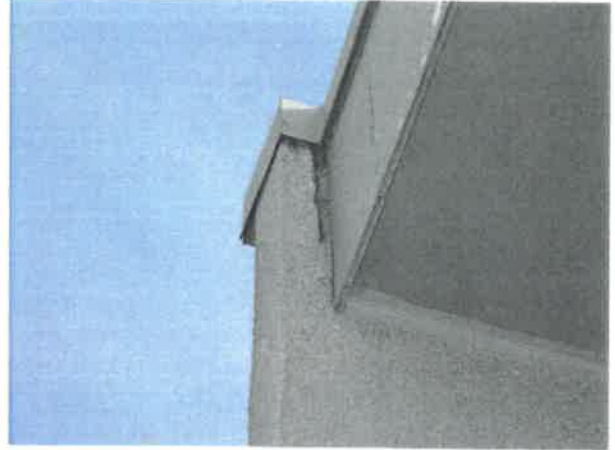
Figure 3-2
Missing Stucco at Fascia to Wall Location

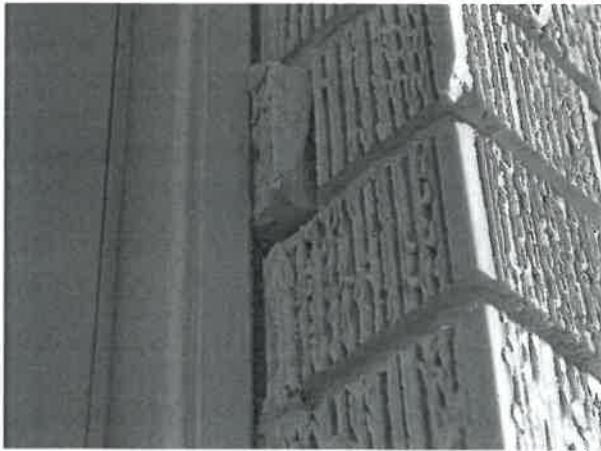
Figure 3-3
Broken Face Bricks at South Exit Door Opening

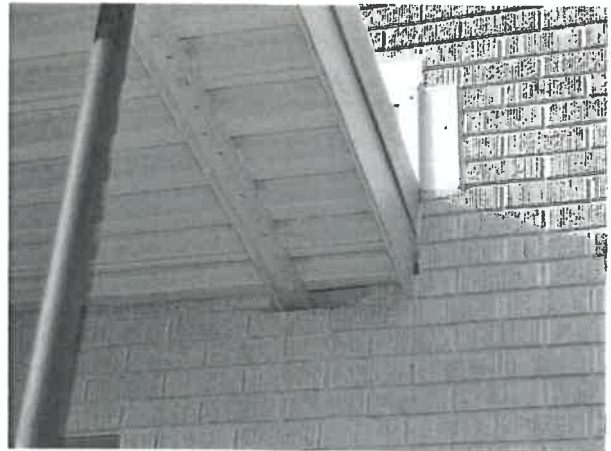
Figure 3-4
Broken Face Bricks Under East Exit Canopy

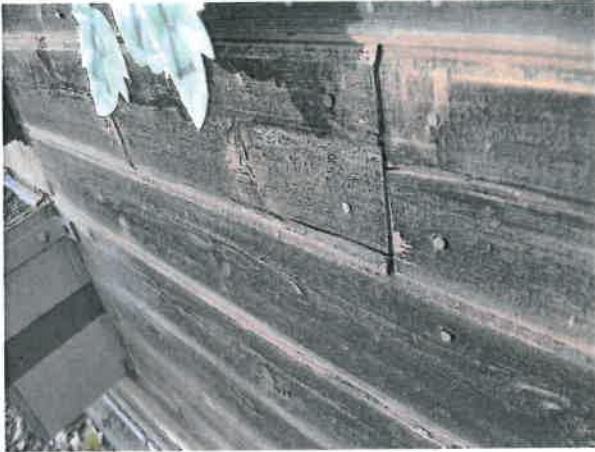
Figure 3-5
Discoloured and Deteriorated Wood Siding

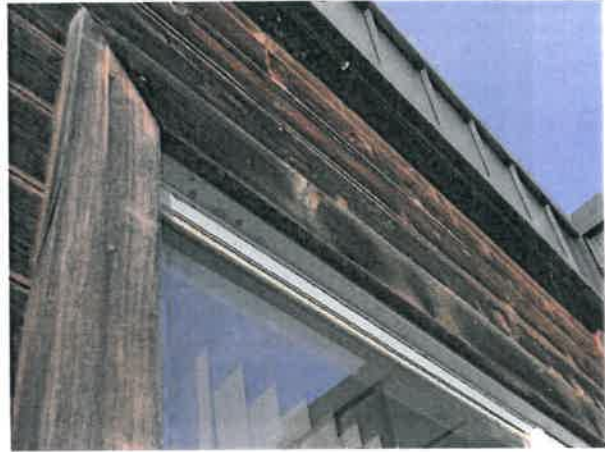
Figure 3-6
Missing Metal Head Flashing Above Window Trim

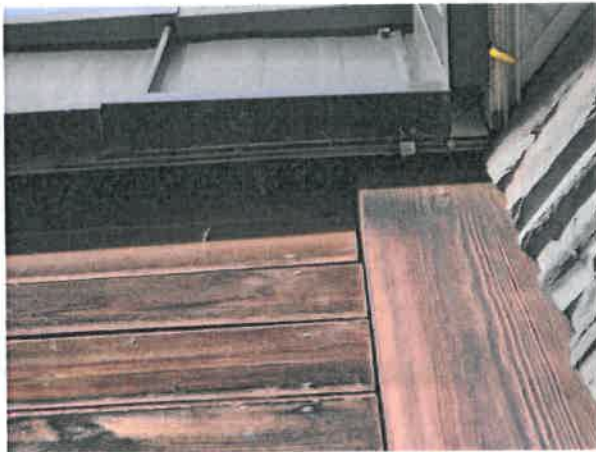
Figure 3-7
Missing Sealants in Vertical Seam

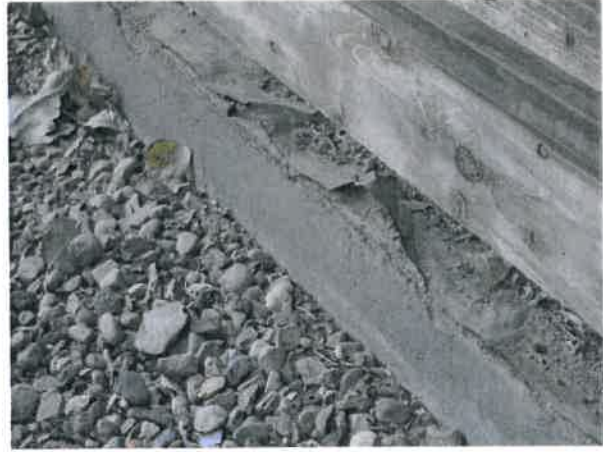
Figure 3-8
Exposed and Deteriorated Building Paper, Missing Base Flashing

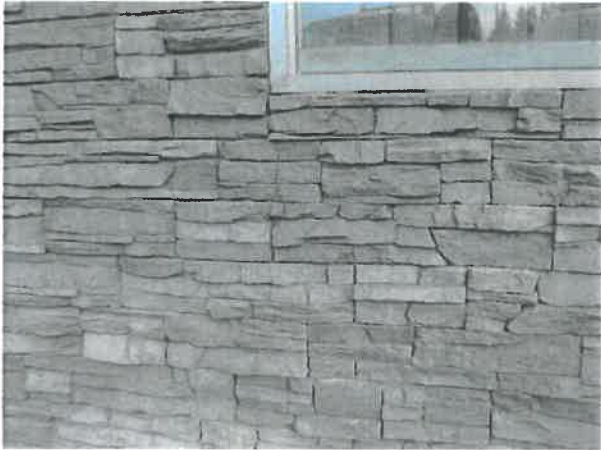
Figure 3-9
Cracks on Stone Veneer

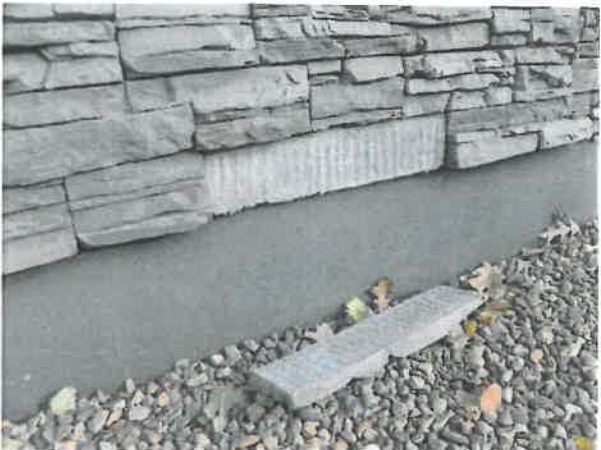
Figure 3-10
Dismounted Stone Veneer

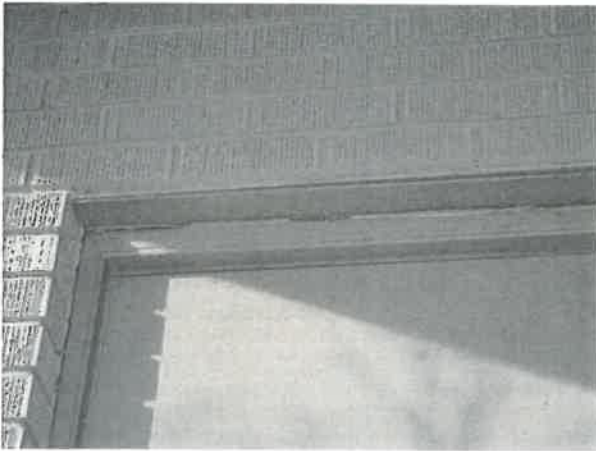
Figure 3-17
Broken Sealant Around Door Frames

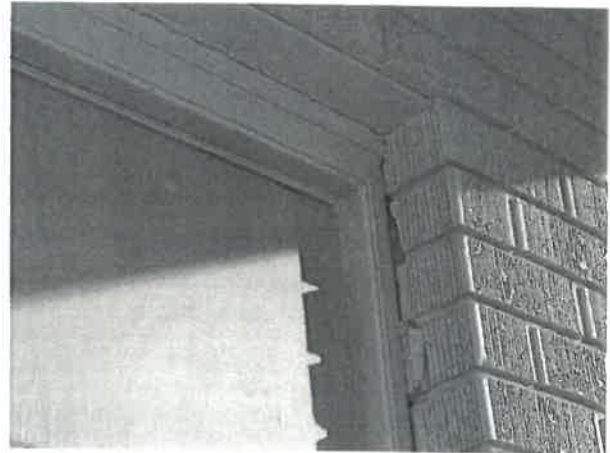
Figure 3-18
Broken Sealant Around Door Frames

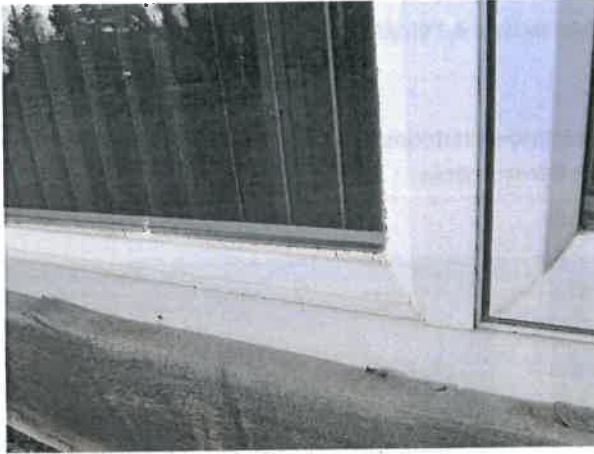
Figure 3-19
Deteriorated Sealant Around Fibreglass Formed Sealed Unit

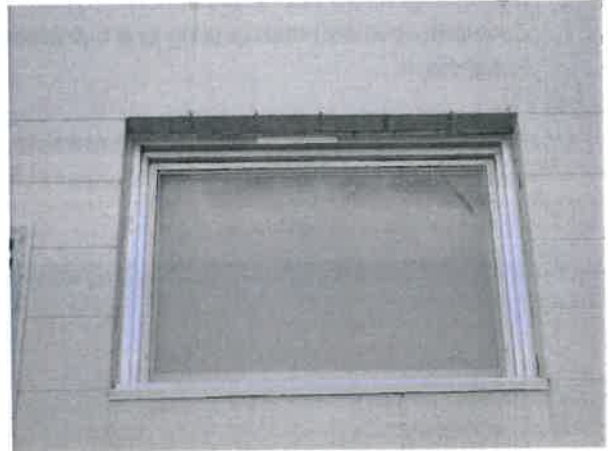
Figure 3-20
Broken Sealant Around Fixed Aluminium Window Frames

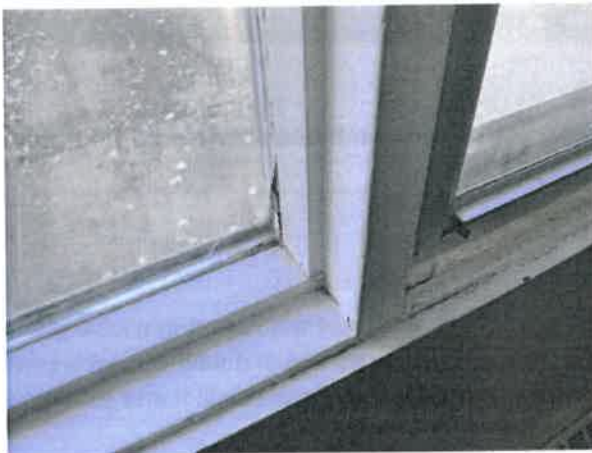
Figure 3-21
Condensation Between Fixed Window Panes, Broken Sealant at Bottom of Vertical Lift Insert

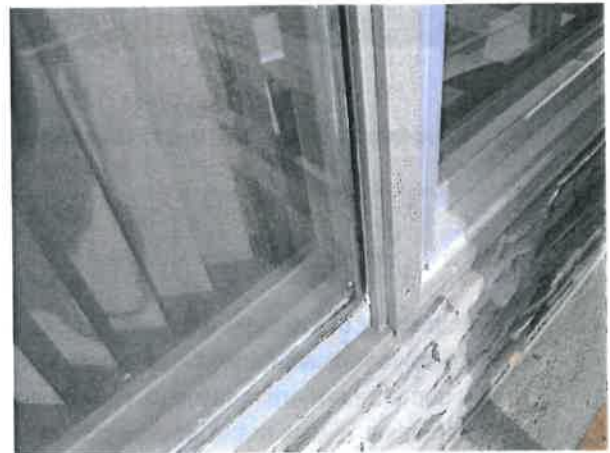
Figure 3-22
Broken Sealant at Bottom of Sealed Unit

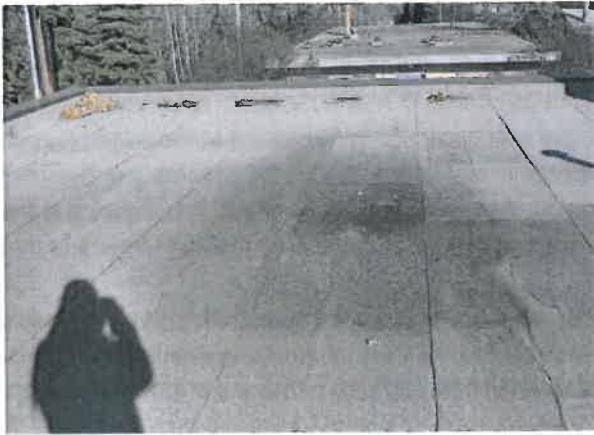
Figure 3-23
Water Ponding Deposits on Roof

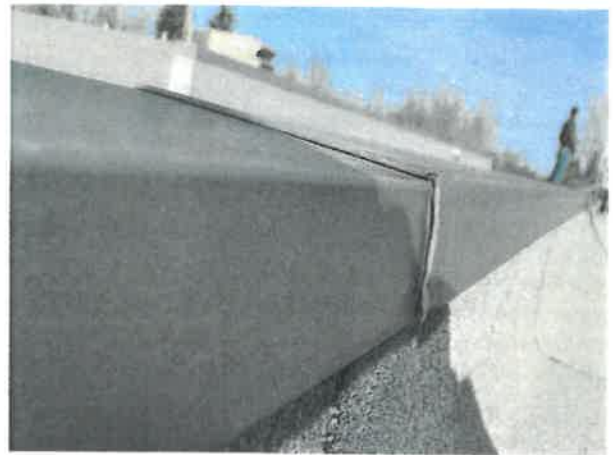
Figure 3-28
Loose and Rusted Cap Flashing Seam

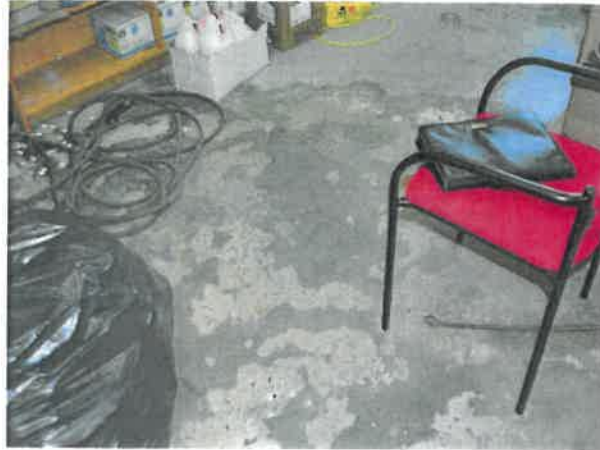
- Painted concrete flooring in the Mechanical Room and Smoke Room and the storage room outside of west building wing's exit. The floor paint is in marginal condition. Concrete shows surface scaling with exposed aggregates in the west part of the Mechanical Room.

Figure 3-31
Concrete Scaling in Mechanical Room

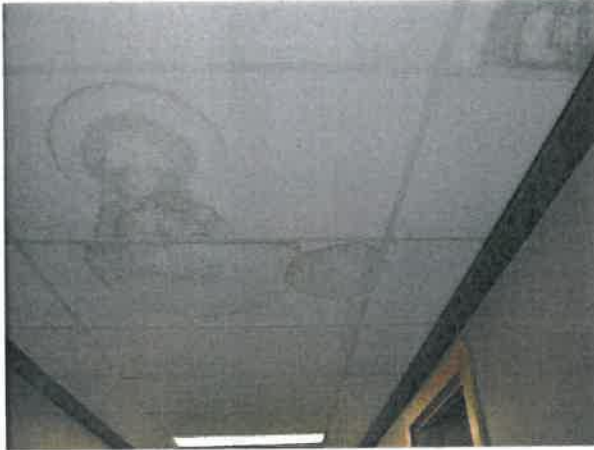
Figure 3-32
Water Stain on Ceiling Tiles Over Corridor

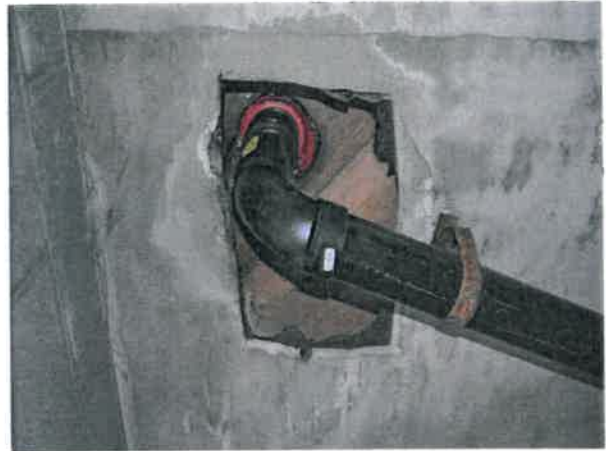
Figure 3-33
Water Stain on Ceiling Around Roof Drain Over Smoke Room

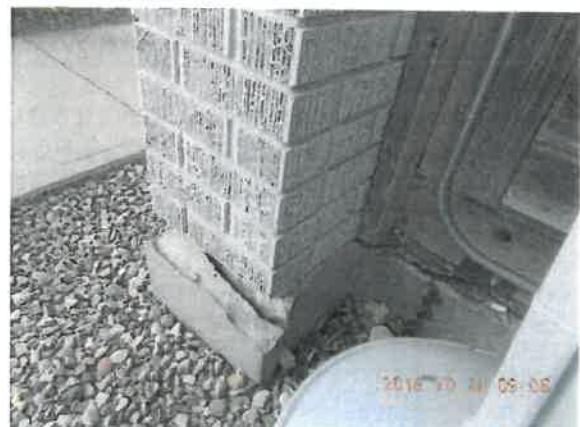
Figure 4-2
Example of Spalled Termination End of Strip
Footing Near Main Entrance

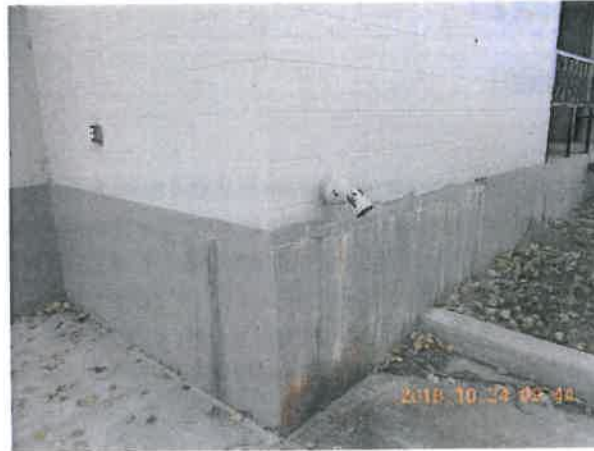
Figure 4-3
Viewing NW Face with Corrosion Staining

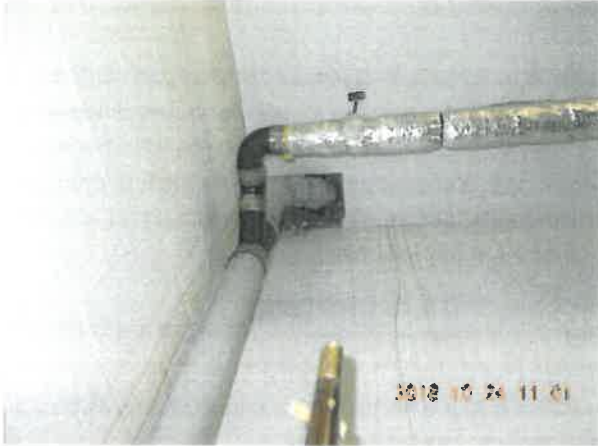
Figure 4-4
Viewing Staining on Wall in Boiler Room

As previously mentioned in Section 3.0, it is recommended to install a new roof system to protect the building and its wood elements. All existing wood decking and joists in an unsuitable condition shall be replaced during the roof replacement. A cost allowance for a portion of deck replacement has been included in the re-roofing estimate of the Architectural recommendations.

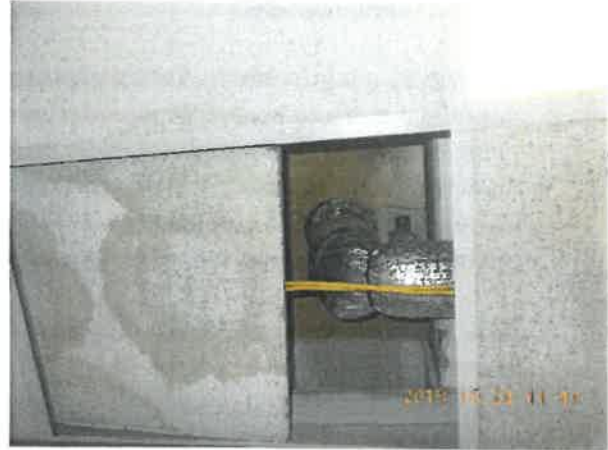
Figure 4-5
Example of Leak at Roof Drain Location

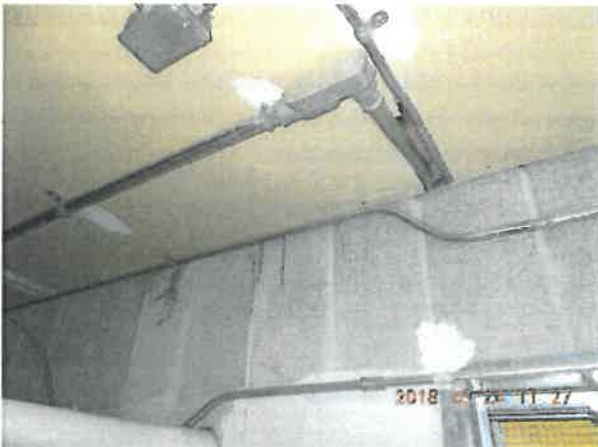
Figure 4-6
Staining on Interior Masonry Wall of Vault Room

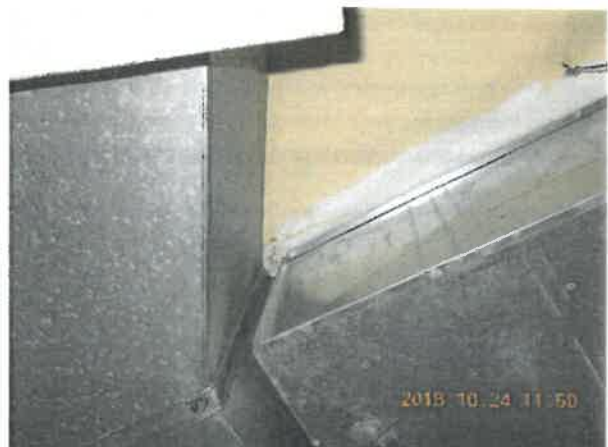
Figure 4-7
Viewing Staining on Drywall Ceiling Above Ductwork

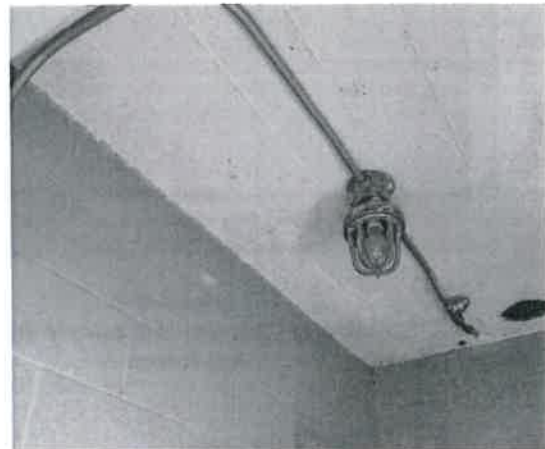
Figure 4-9
Viewing Other Side of Masonry Wall Within Oxygen Storage Room. No cracking visible.

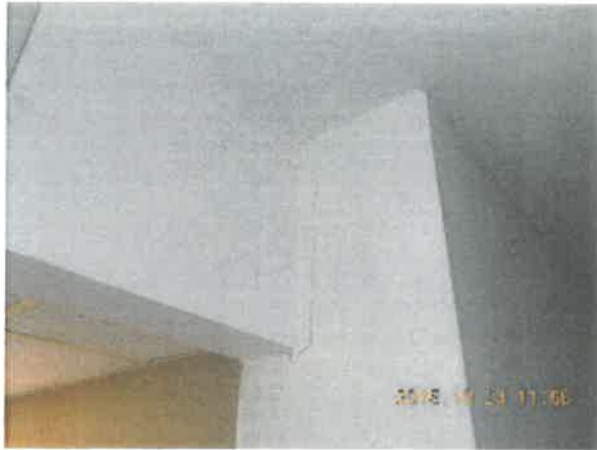
Figure 4-10
Viewing Cracking at Beam Bulkhead

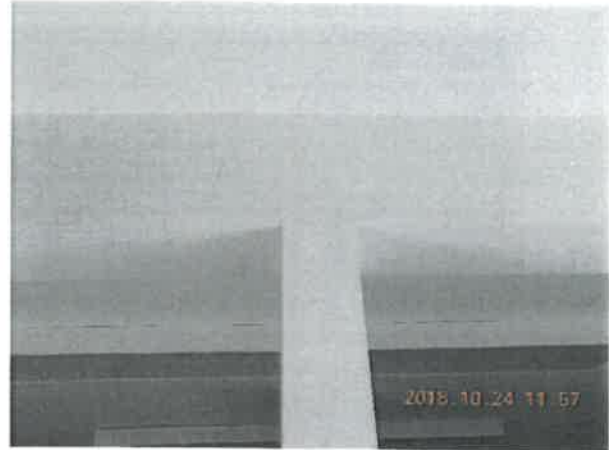
Figure 4-11
Viewing Cracking at Column Connection to
Beam and Screws Pushing Out at Ceiling

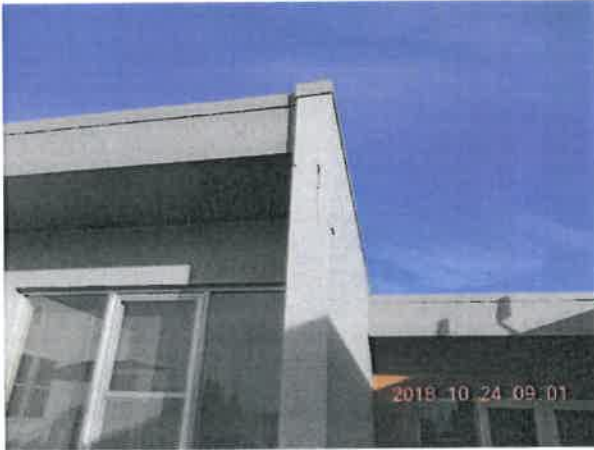
Figure 4-12
Viewing Split Face of End Unit of Bond Beam
at SE Corner of Chamber

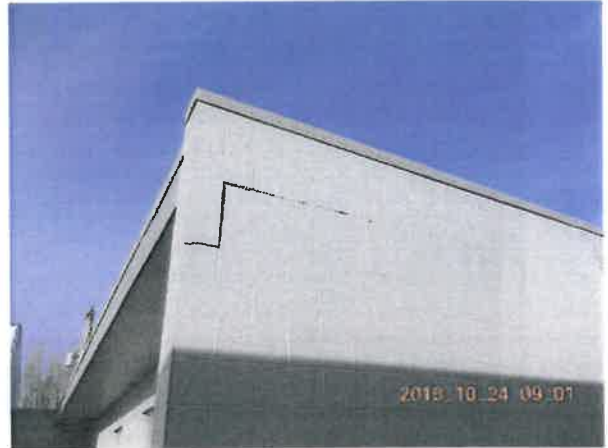
Figure 4-13
Viewing Horizontal Crack in Above Bond Beam
at SE Corner of Chamber

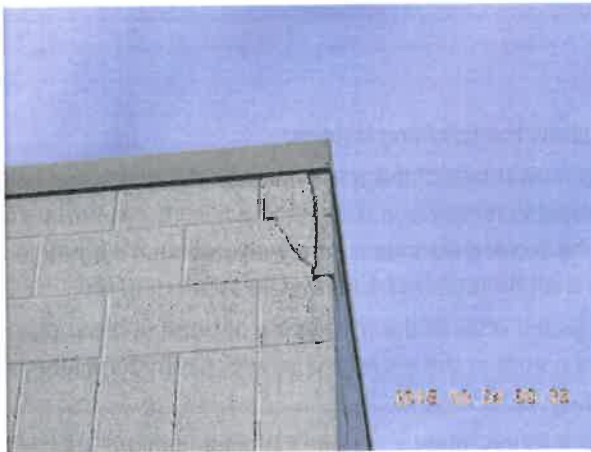
Figure 4-14
Viewing Blocks Requiring Repair at NW Corner
of Vault

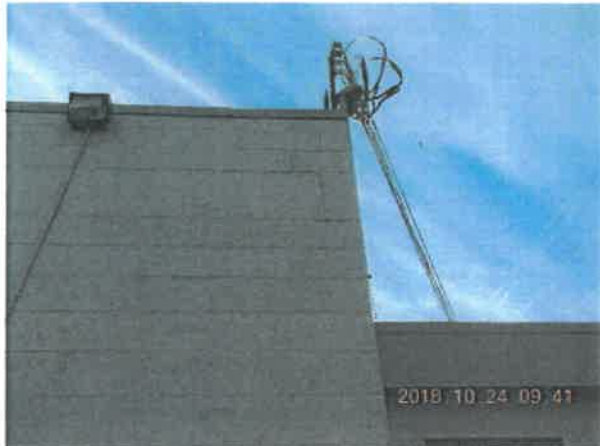
Figure 4-16
Viewing Wide Cracking Through Joints at
NW Corner Boiler Room

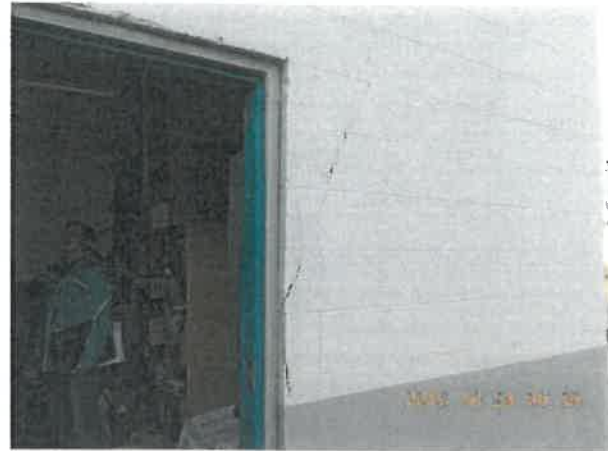
Figure 4-17
Viewing Severe Crack Near Door in North Wall

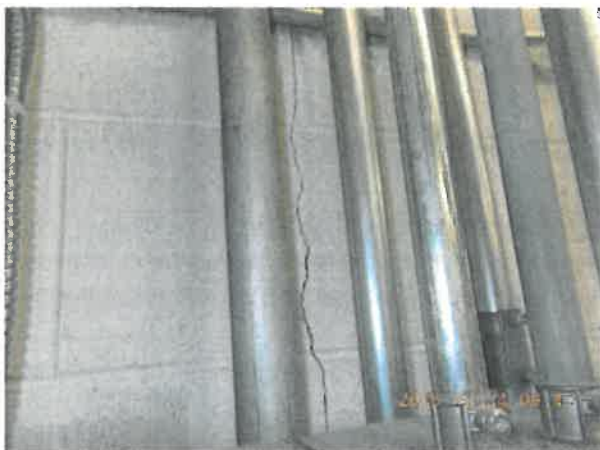
Figure 4-18
Viewing Wide Crack in Interior Face of North
Wall of Boiler Room

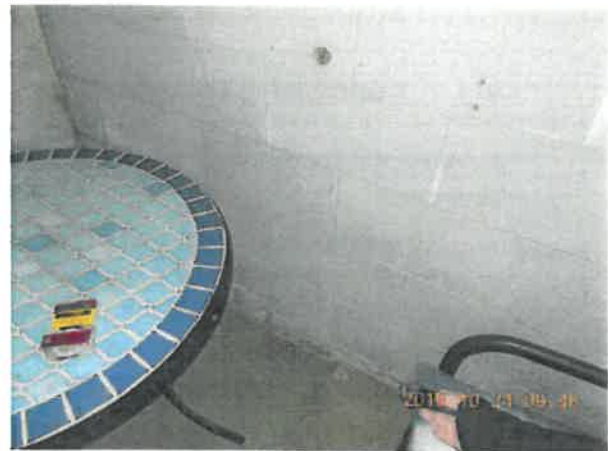
- Numerous penetrations were observed within the masonry walls. Three of these locations show masonry fill being exposed or collecting below the areas. The drawings confirm that the fill is Zonolite; a vermiculite insulation product that is known to contain asbestos. If the material is contained and not disturbed, it is rarely considered hazardous. It is recommended that the expelled material be tested for asbestos, and be collected by someone trained in asbestos abatement. The holes in the masonry walls shall be adequately sealed so the insulation is not exposed.

Figure 4-19
Viewing Penetration with Vermiculite Fill Being
Expelled in the Original Incinerator Room

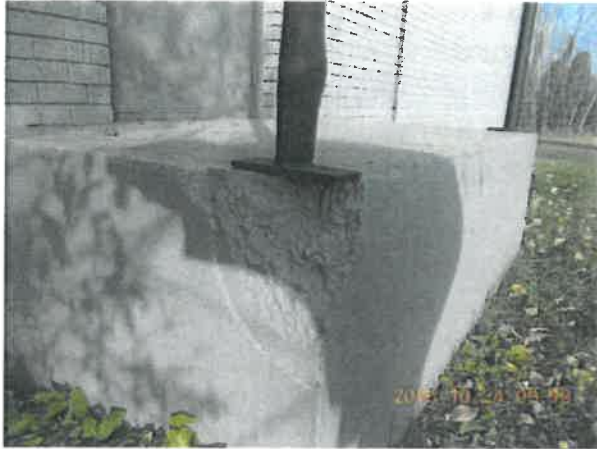
- The east apron to the original oxygen storage room has a large chip under the canopy column. The steel column has bulged and cracked at its base and is likely due to trapped water in freezing conditions. Although not an immediate concern, the concrete should be patched and the section of the column repaired.
- Horizontal cracking was visible on the north apron of the north wing. This should be sealed to prevent water ingress.
- The concrete stair apron to the west entrance of the north wing has cracked and settled. This is not a critical item for repair at this time, but if it creates a pedestrian trip hazard, it should be replaced.

Figure 4-22
Viewing Damage to Concrete and Steel Column
of East Apron

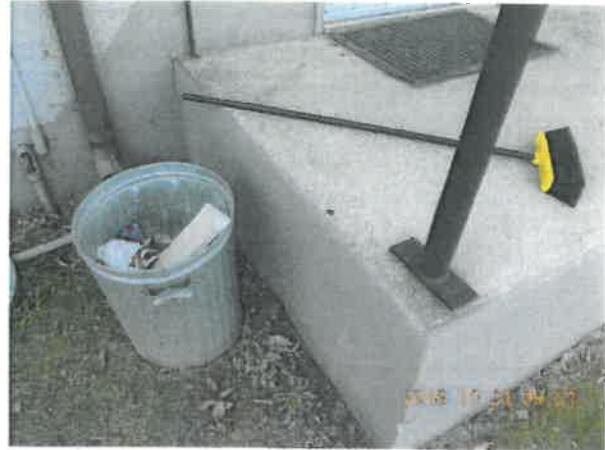
Figure 4-23
Viewing Horizontal Crack on North Apron of
North Wing

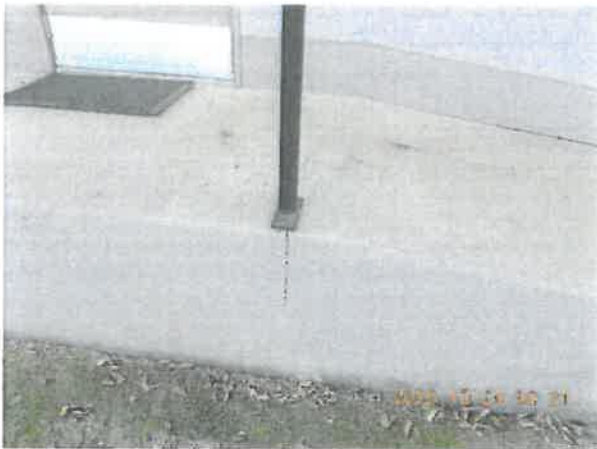
Figure 4-24
Viewing Vertical Crack under Column on
North Apron of North Wing

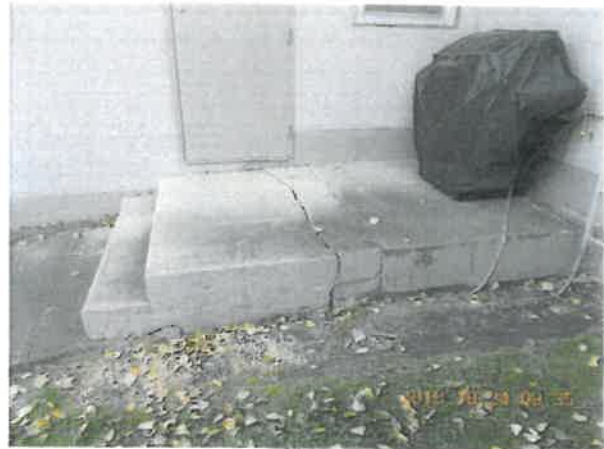
Figure 4-25
Viewing Wide Cracking in West Entrance of
North Wing

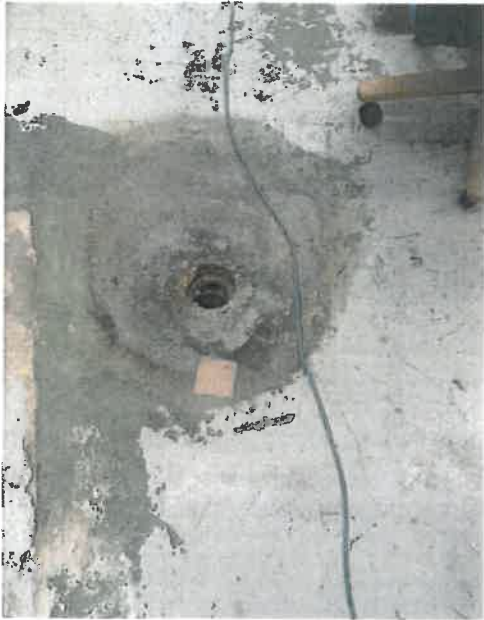
The existing sanitary drain system is routed through the crawlspace and connects to the municipal sewage system at the southwest. Floor drains in various locations are missing drain grates, these are intended to stop leaves and debris from entering the drainage system. These shall be reinstalled to protect the system from foreign debris.

Figure 5-5
Floor Drain Missing Grate

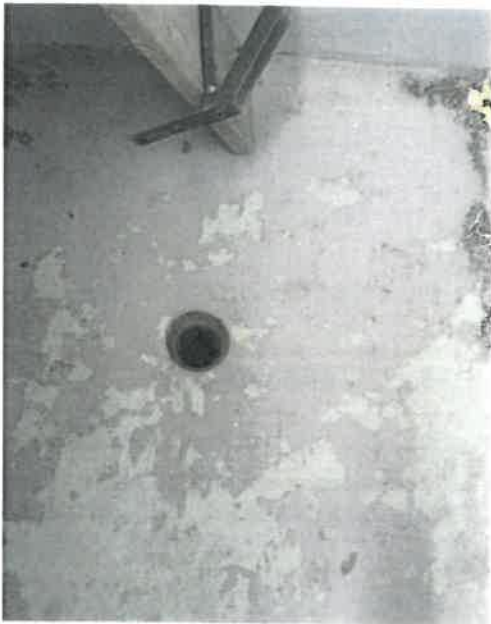
Figure 5-6
Floor Drain Missing Grate

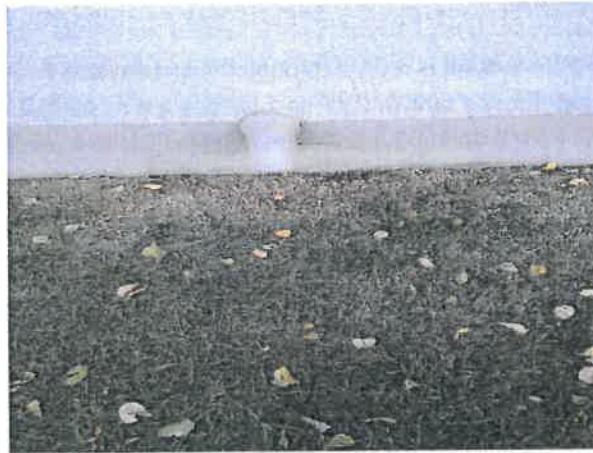
The roof rainwater is collected in roof drains and discharge on grade through downspouts. The overall storm system appears to be in fair functioning condition. Downspouts at various locations are close to the building foundation, we recommend the addition of concrete splash pads to convey storm water away from the foundation walls.

Figure 5-7
Downspouts Close to Foundation

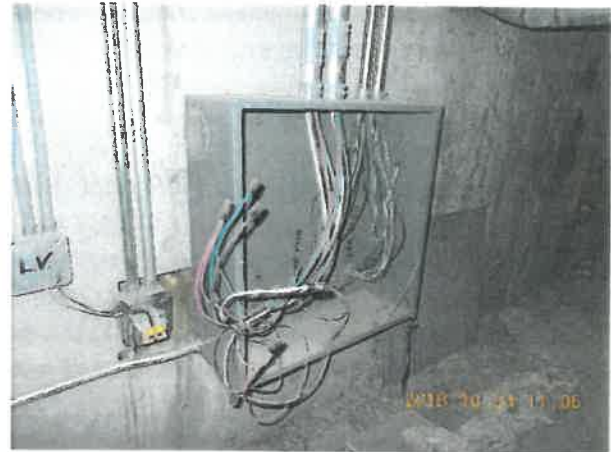
Figure 6-10
JB Cover Missing

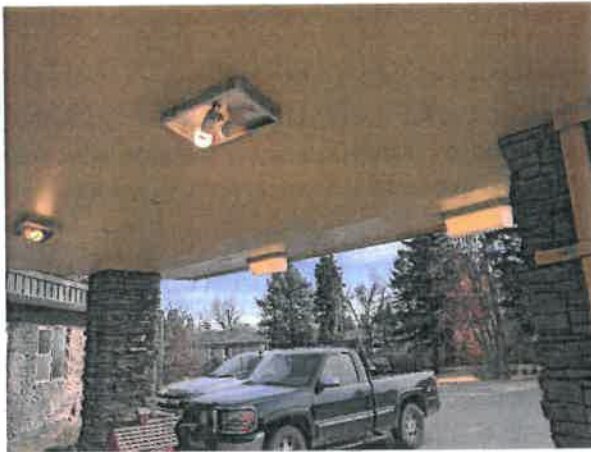
Figure 6-11
Main Entrance Lighting

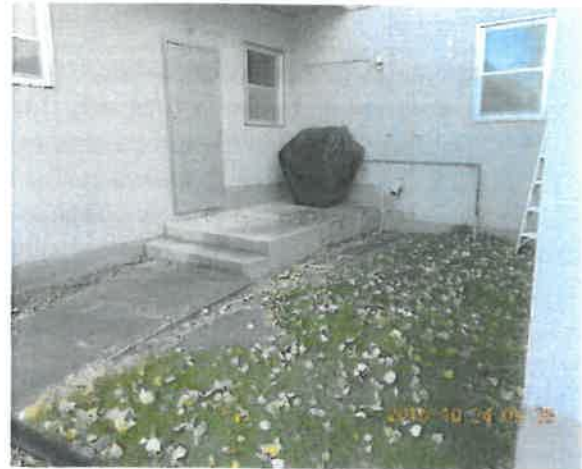
Currently, there is exposed wiring (unknown if powered) above the north parking lot exit door and the light above the barbeque is broken. these lights should be replaced to provide adequate lighting above exit doorway.

Figure 6-14
Light Broken, Exposed Wiring Above Door
