SMOKY LAKE COUNTY

AGENDA: County Council Budget Meeting to be held on
Thursday, September 10th, 2020, at 9:00 A.M.,
in the County Council Chambers, Smoky Lake.

4.1 Smoky Lake County Administration Building Assessment ©

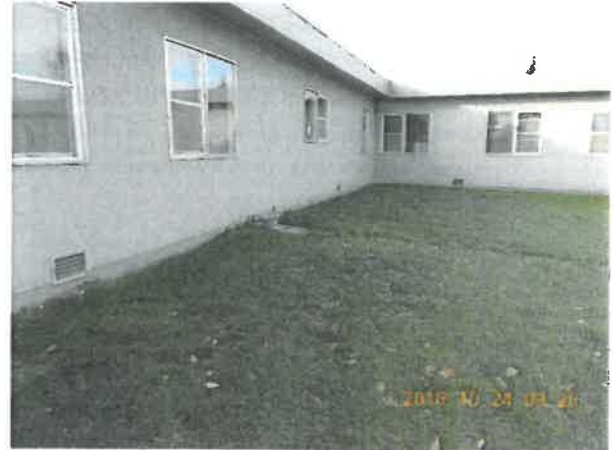
Figure 2-4
Viewing Depression in Grade Along North Wall

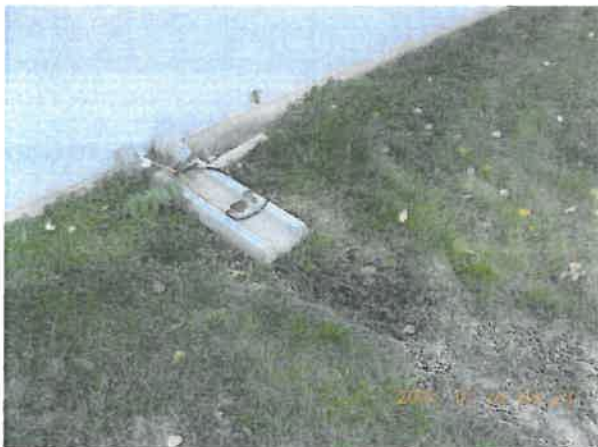
Figure 2-5
Viewing Scour at North Roof Drain Location

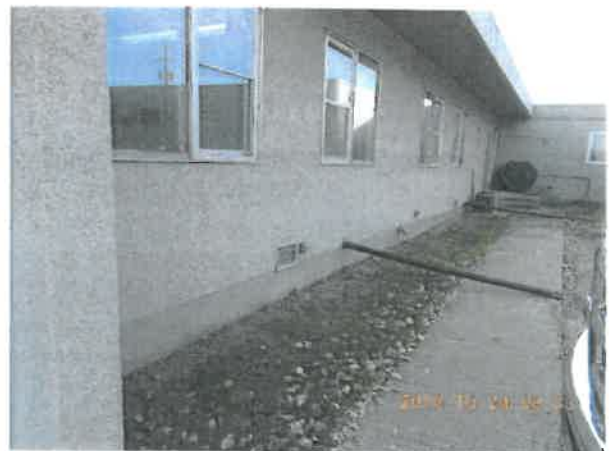
Figure 2-6
Viewing Ponding Location at West Wall

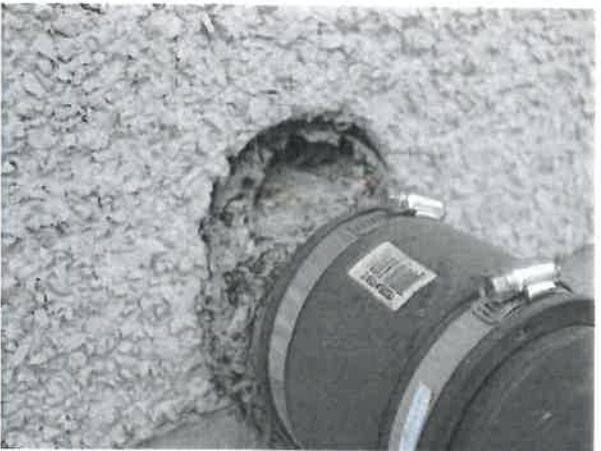
- Cracking is visible through out the stone veneer's surface. One veneer piece dismantled from the wall.
- Numerous electrical and mechanical pipe penetrations are unsealed.

Figure 3-12
Unsealed Pipe Penetration

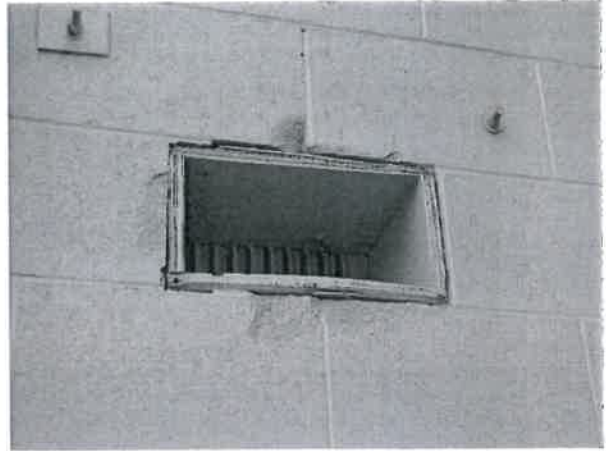
Figure 3-14
Unsealed Opening Around Louvre to Mechanical Room

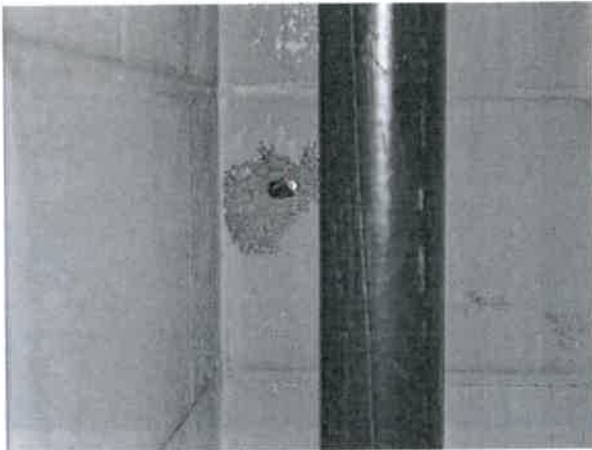
Figure 3-15
Unsealed Hole on the Concrete Wall of Smoke Room

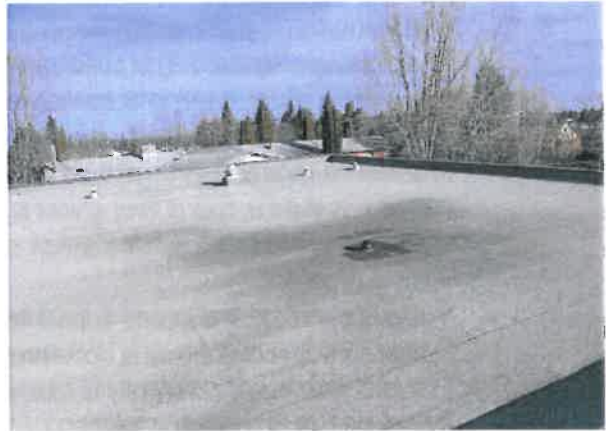
- It was observed that deposits appeared on the roof and around the roof drain at numerous locations indicating that roof ponding is occurring at those locations. Roof ponding, due to inappropriate slope to roof drains, could potentially cause water to seep through from under the roof material and into the roof system and building interior.

Figure 3-24
Water Ponding Deposit Around Roof Drain

The existing roofing system should be replaced with new by the following methods:

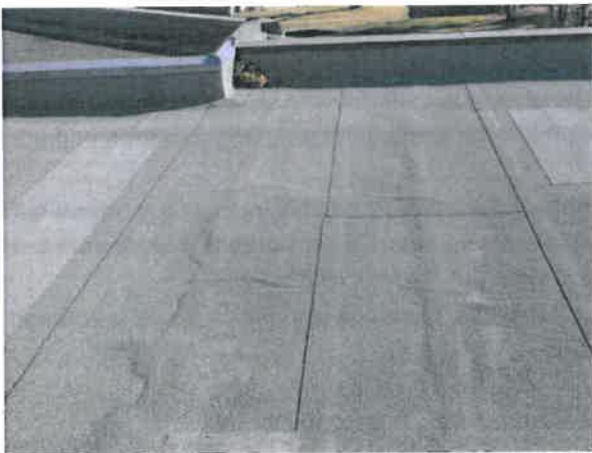
Figure 3-25
Blister Strips on the Roof

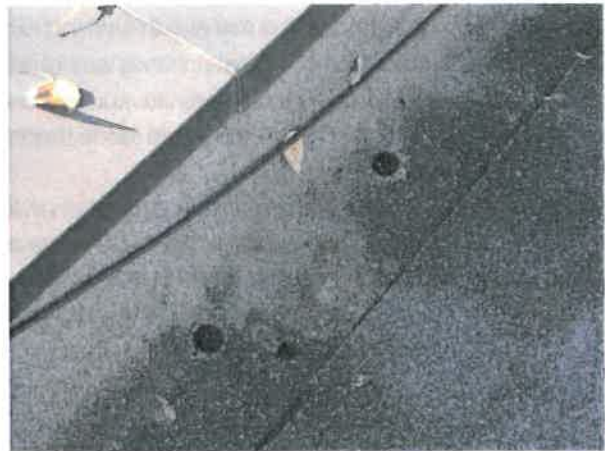
Figure 3-26
Moss at the Parapet Base on the Roof

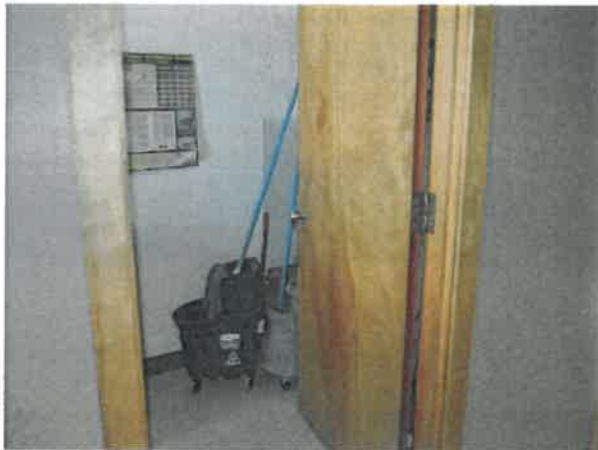
Figure 3-34
Wood Door and Frame to Janitor Room Not Fire-Rated

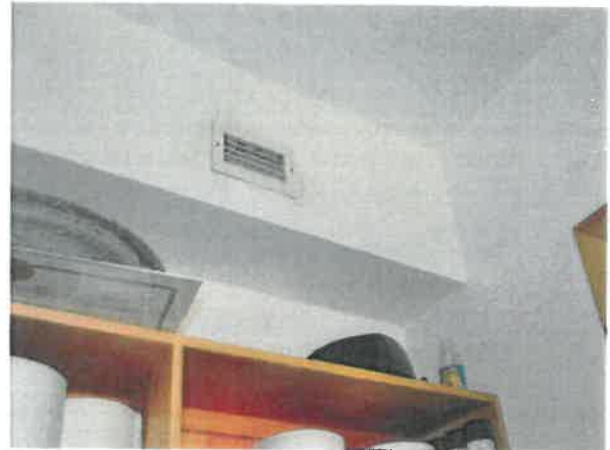
Figure 3-35
Vent in Janitor Room Not Fire-Stopped

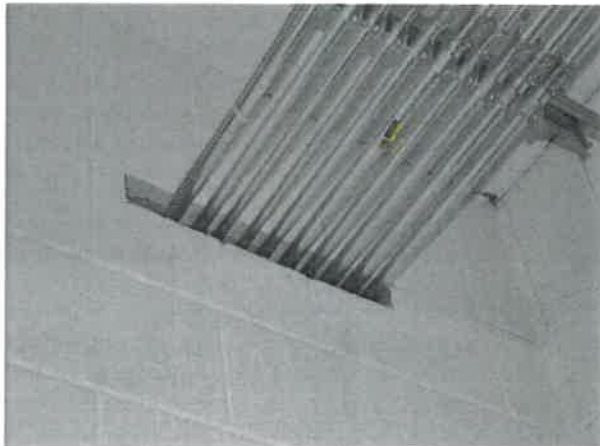
Figure 3-36
Conduits' Wall Penetrations Requiring Fire Sealant in Mechanical Room

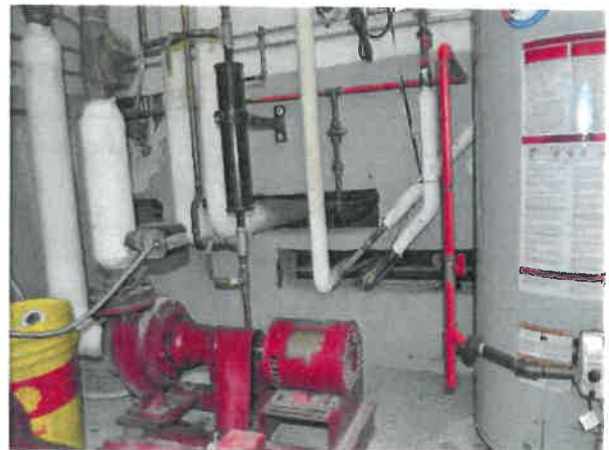
Figure 3-37
Pipe's Wall Penetrations Requiring Fire Stopping or Sealant

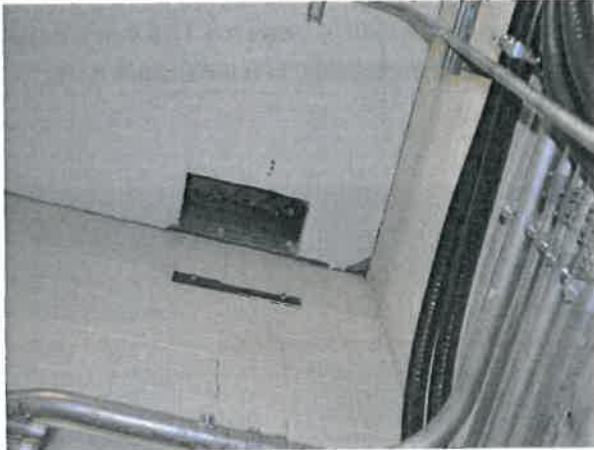
Figure 3-38
Opening on Ceiling Requiring Fire Sealant in Mechanical Room

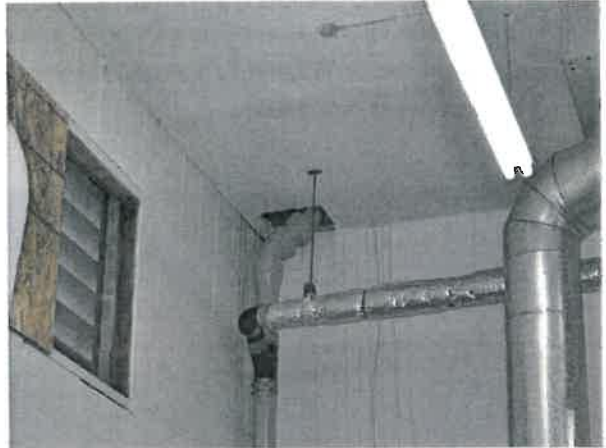
Figure 3-39
Pipe's Ceiling Penetration Requiring Fire Sealant in Mechanical Room

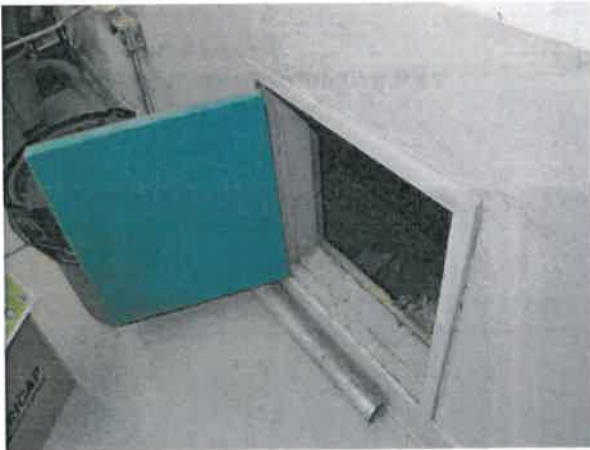
- Penetrations to crawlspace are not fire sealed in accordance with ABC 2014, Section 3.1.9 Penetrations in Fire Separations and Fire Rated Assemblies.
- Access door and frame to crawlspace are not fire-rated.

Figure 3-40
Access Door and Frame to Crawlspace in Mechanical Room Not Fire-Rated

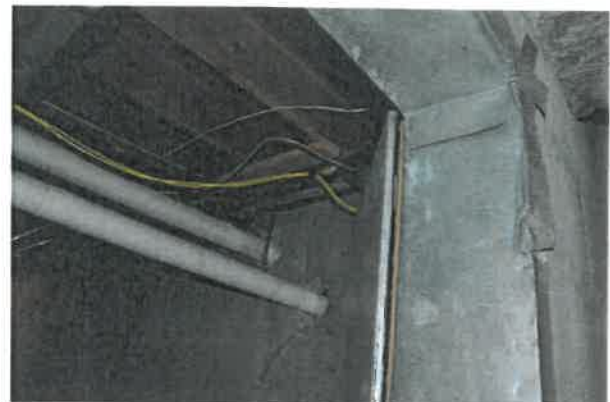
Figure 3-43
Access Door and Frame to Crawlspace in
Basement Not Fire-Rated

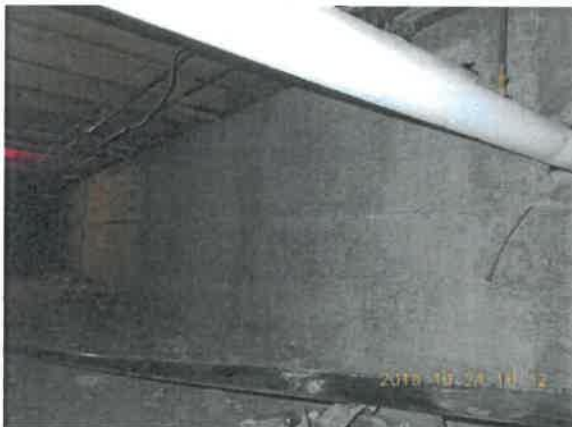
Figure 4-1
Interior Strip Footings Appear to be in
Good Condition

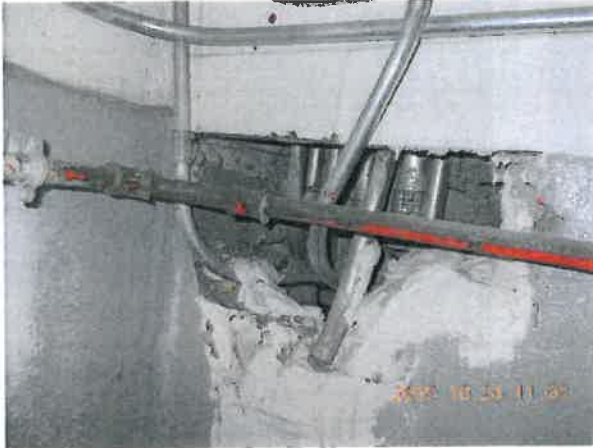
Figure 4-20
Viewing Vermiculite Fill at Conduit Penetration
Into Masonry Wall Within Boiler Room at the
SE Corner

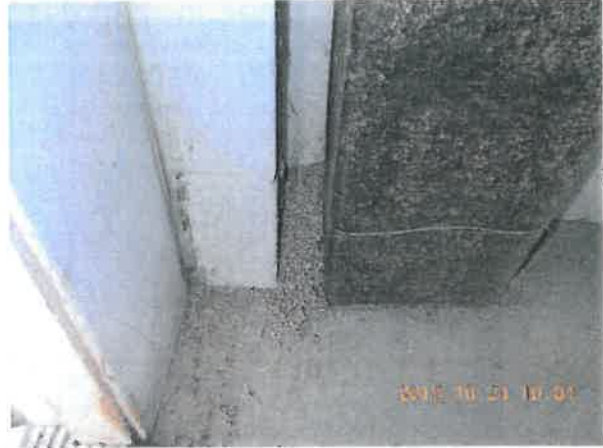
Figure 4-21
Potential Vermiculite Fill in Oxygen
Storage Room

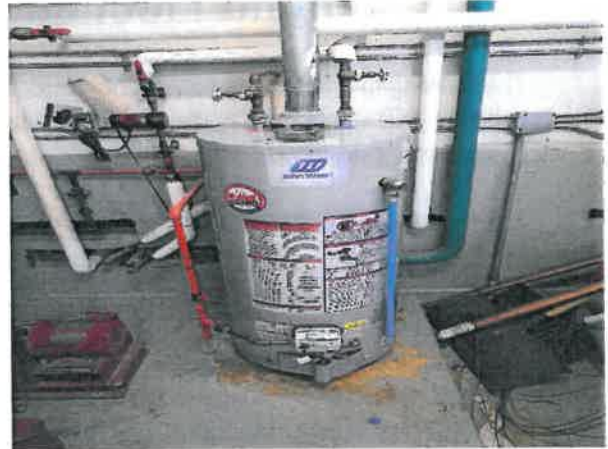
A single gas-fired domestic water tank heater, also located in the boiler room, provides the lavatories and sinks with domestic hot water. The domestic water heater is a John Wood model JW840S40N manufactured in 2014. The domestic water heater appears to be in good functioning condition with 20 years' service life with proper maintenance. A recirculation loop and recirculation pump maintain flow in the domestic hot water system. The recirculation pump is Grundfos UP10-16, and appears to be in good working condition.

Figure 5-2
Domestic Water Heater

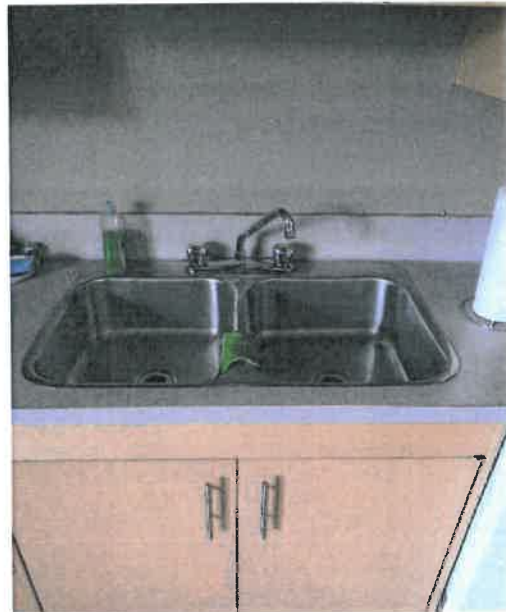
The plumbing fixtures on the main floor of the building consist of manually operated lavatories, flush-tank water-closets in the seven washrooms, sinks in various rooms, and non-freeze hose bibbs on the building perimeter. All plumbing fixtures appear to be in good functioning condition.

Figure 5-3
Washroom Group

Figure 5-4
Double Compartment Sink

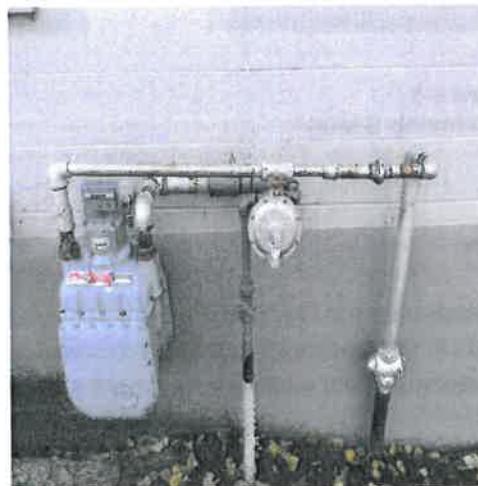
The gas meter and regulator set that provides natural gas to the building is located on the north exterior wall, just outside the boiler room. The gas piping supplying the boilers, water heaters and BBQs is painted and appears to be in good condition. No required repairs or upgrades were identified for the gas system.

Figure 5-8
Gas Meter and Regulator

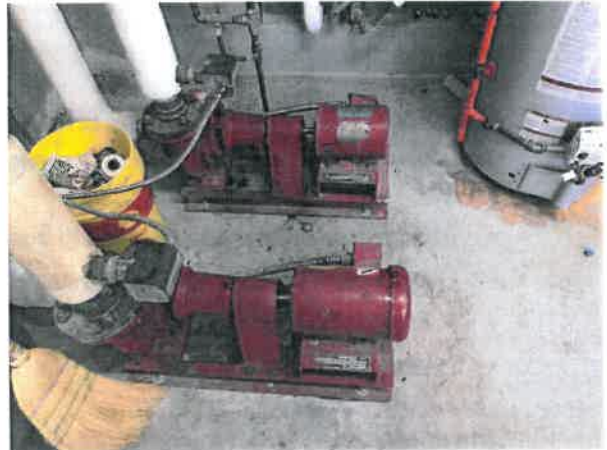
The heating distribution pumps are Bell & Gossett model 2/2.1 AB manufactured in 1988, each with a capacity of 7.5 L/s. These are at end of typical life expectancy. However, since these pumps appear to be in fair working order, replacement should be planned with next major upgrade or upon failure. The two pumps are currently operating at constant speed, when these pumps are replaced, we recommended that pumps shall vary flow in response to building load requirements using variable speed drives to save energy.

Figure 5-10
Heating Water Pumps

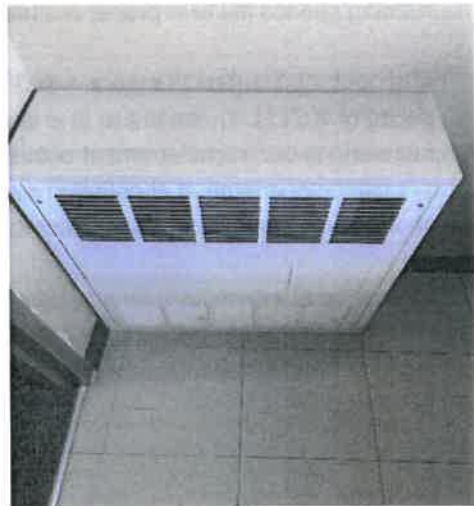
The terminal elements including baseboard heaters, force flow heaters, unit heaters and heating coils are reaching typical life expectancy within five years. However, since these terminals appear to be in fair working condition, replacement can be planned for the next major upgrade or upon failure.

Figure 5-11
Baseboard Radiant Heater

Figure 5-12
Force Flow Heater

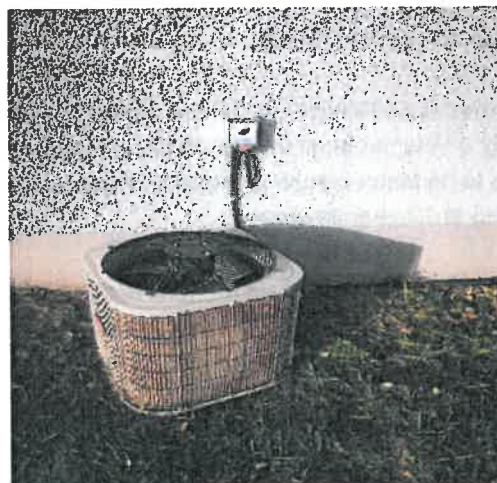
One of the condenser units is placed on grade and unsupported. This could cause excessive noise and the fan could wear if the unit does not sit level. It is recommended to install the unit on a concrete pad to keep it level through vibration and all-weather conditions.

Figure 5-15
Condenser Unit Standing On Grade

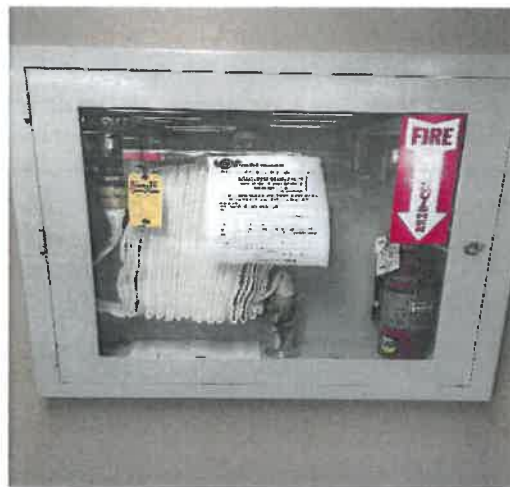
Portable fire extinguishers are installed throughout the building including the boiler room and common corridors.

Figure 5-16
Fire Hose Cabinet with Fire Extinguisher

It is recommended to maintain, test and inspect the fire protection system in accordance with NFPA 10, NFPA 14 and the local authority having jurisdiction.

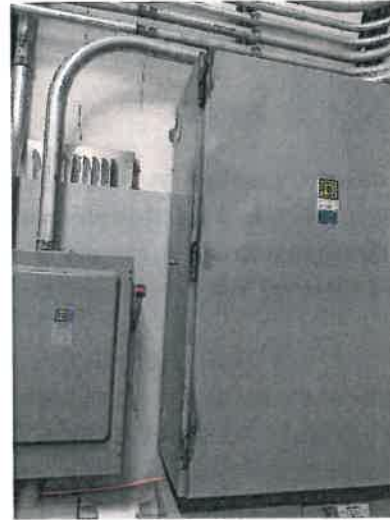
The utility fuse enclosure was unable to be accessed at the time of assessment, upon visual inspection it appears to have had electrical issues based on the black soot located on the exterior of the box. It is strongly recommended this enclosure is replaced, and an assessment of the building electrical load completed to ensure the upstream protection is sized appropriately.

Figure 6-2
Black Substance Observed on Utility Fuse Box

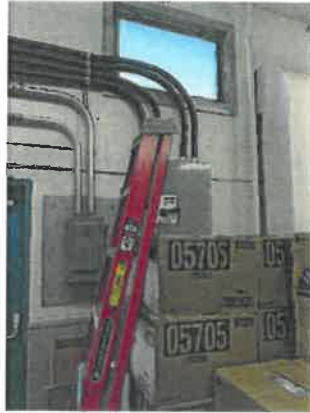
Currently, there are items stored in front of the electrical equipment, this does not meet CEC. As per Section 2-308, there must be a minimum of 1.0 m working space in front of all electrical equipment, all the stored items will need to be moved. This is also a fire safety hazard as there are flammable items.

Figure 6-3
Insufficient Space in Front of Electrical Equipment

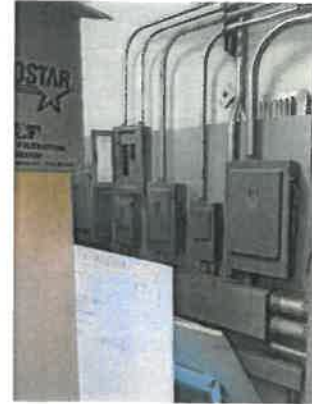
Figure 6-4
Insufficient Space in Front of Electrical Equipment

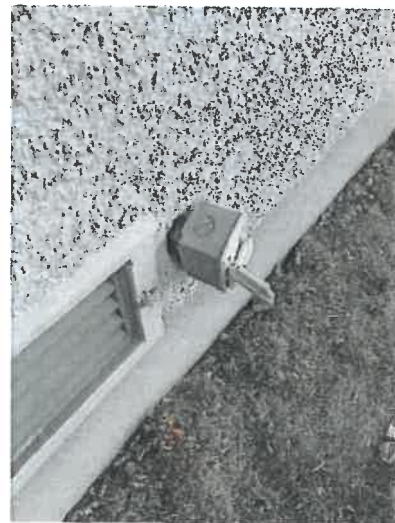
All exterior receptacles were a weather protected type. Based on the panel schedule, all exterior outlet receptacles are powered from a GFI breaker. Some exterior receptacles were missing the weatherproofing insulation, these receptacles should be replaced. An exterior receptacle by the north parking lot is damaged and should be replaced and properly secured to the building. New exterior receptacles must have a weatherproof cover, as per CEC section 26-708. A conduit junction box located on the north side of the building was missing a cover plate, which should be installed to meet code.

Figure 6-6
Damaged Exterior Receptacle

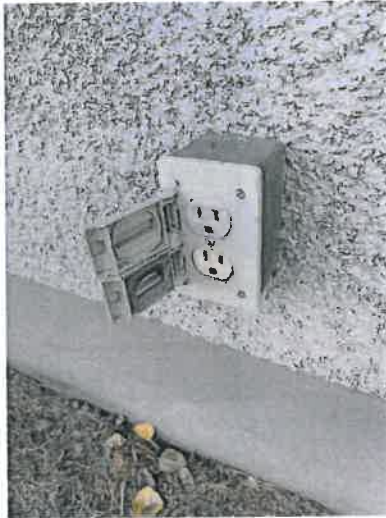
Figure 6-7
Missing Weatherproof Insulation

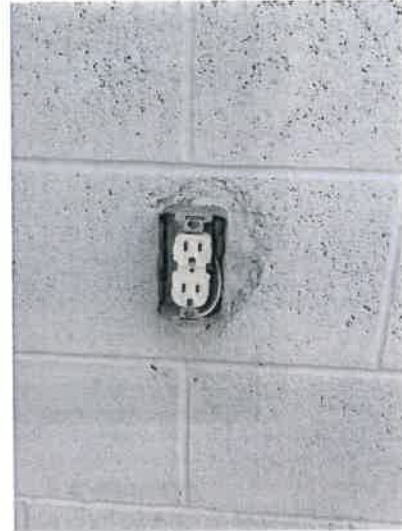
Figure 6-8
Exterior Receptacle Cover Missing

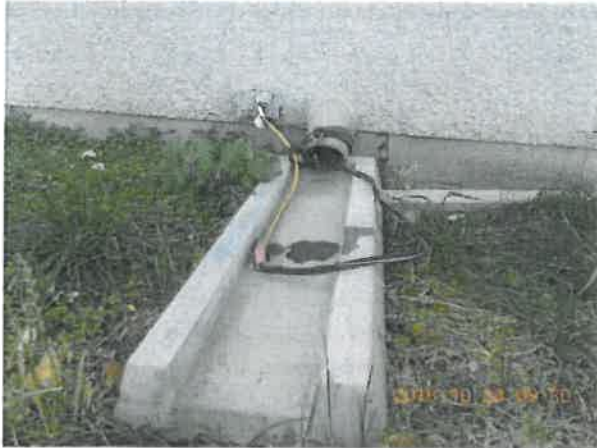
The existing heat trace installed on south side of building is plugged into a standard receptacle. As per CEC 62-116 (1), ground fault protection shall be provided for electric heating cable sets. Based on the panel schedule and observing the breakers in the panel, the exterior outlet is powered from a GFI breaker, which meets code. The heat trace should be secured to the splash pad, to ensure it does not come in contact with grass.

Figure 6-9
Exterior Heat Trace
