SMOKY LAKE COUNTY

AGENDA: County Council Budget Meeting to be held on
Thursday, September 10th, 2020, at 9:00 A.M.,
in the County Council Chambers, Smoky Lake.

4.1 Smoky Lake County Administration Building Assessment ©

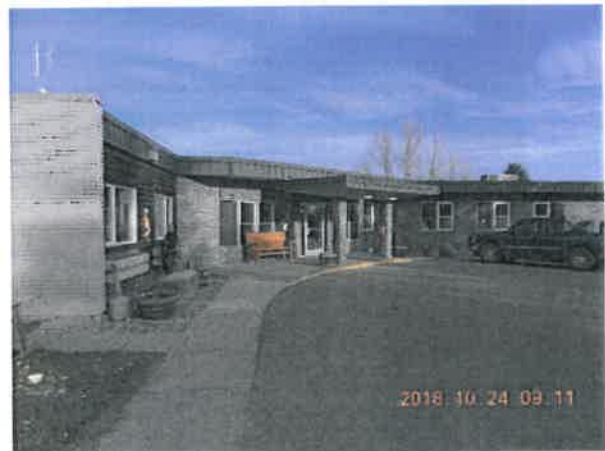
Figure 2-8
Viewing Portion of South Sidewalks

Work Description	Priority	Estimated Cost
Replace brick stone walkway with concrete sidewalks	Medium	\$20,000
Miscellaneous crack repairs to concrete sidewalks	Medium	\$2,000
TOTAL		\$22,000

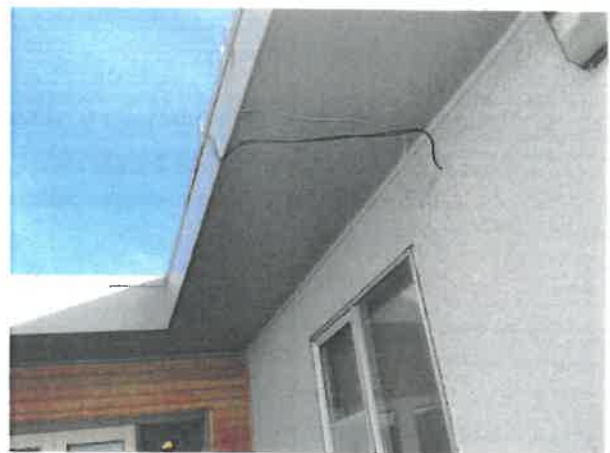
Figure 3-30
Non-vented Soffit

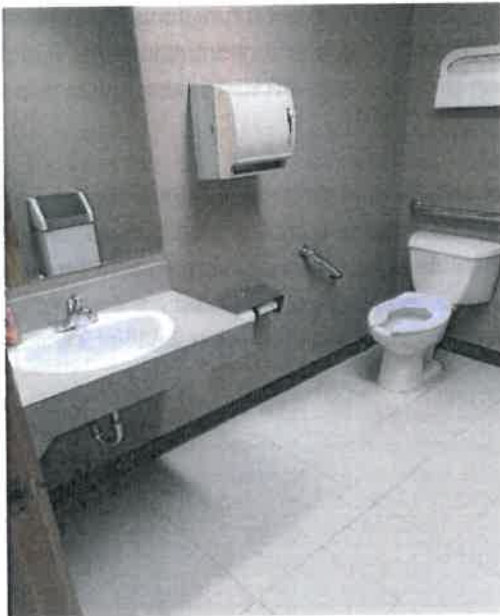
The plumbing fixtures on the main floor of the building consist of manually operated lavatories, flush-tank water-closets in the seven washrooms, sinks in various rooms, and non-freeze hose bibbs on the building perimeter. All plumbing fixtures appear to be in good functioning condition.

Figure 5-3
Washroom Group

Figure 5-4
Double Compartment Sink
